Advisory Region Cooke City Longitude -109.95W Latitude 45.05N Avalanche Details: <u>Natural Avalanche on Henderson Mountain</u> Cooke City, 2022-01-13

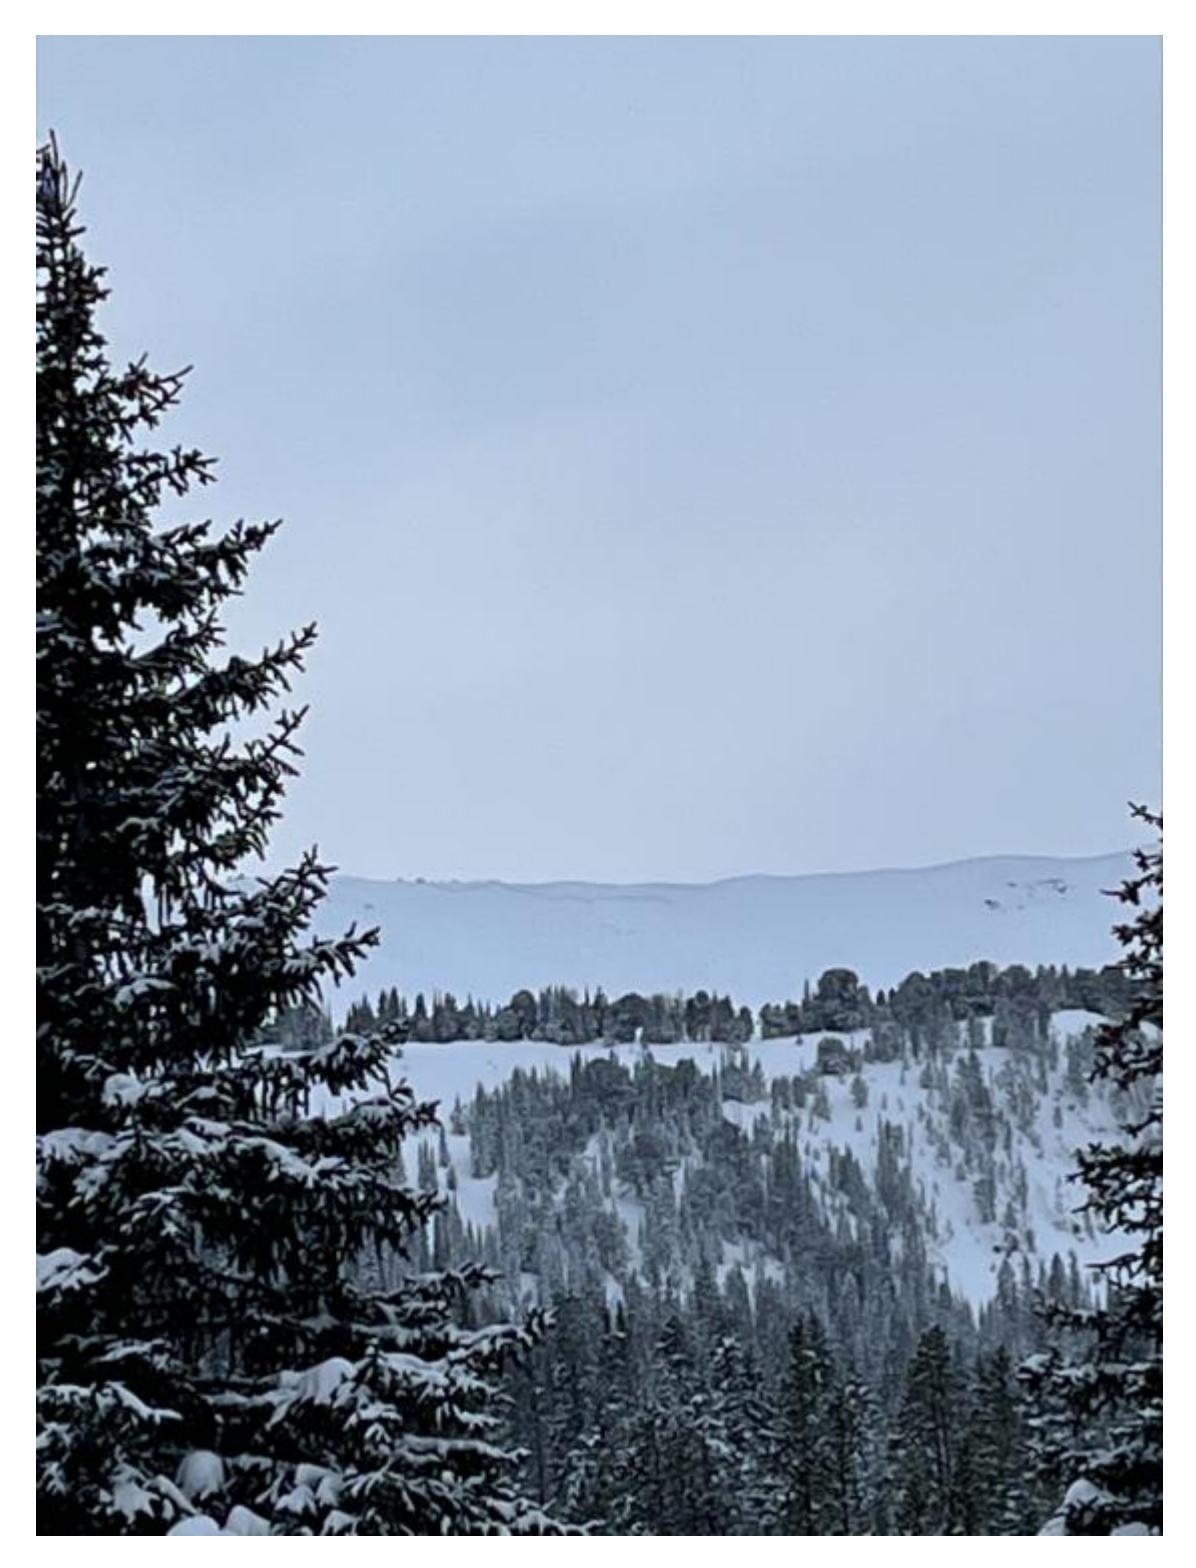
A cornice collapse likely triggered this large natural avalanche on 27 Dec 2021. The crown was 4-6' deep. Photo: S. Culotta
